Boiler Feedwater O₂

COVEY CASE STUDY

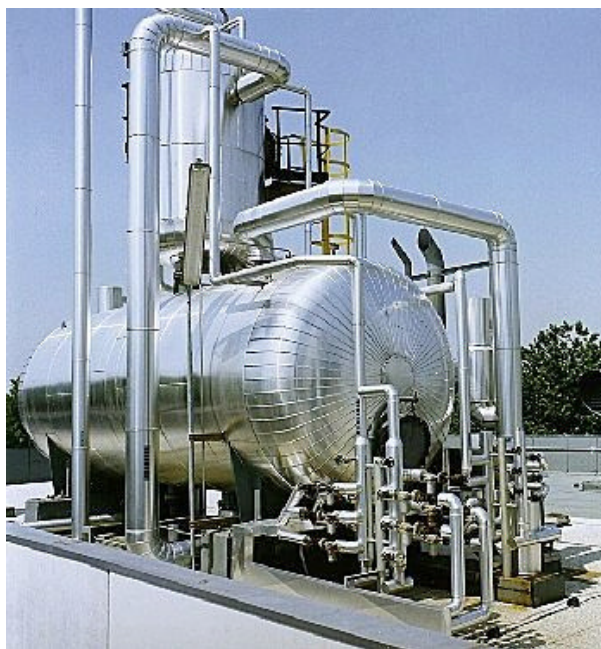
There was still something about the oxygen trends that looked strange to us. When we thought about it clearly, it was the erratic nature of the oxygen trends – a tank with steam bubbling up through it should be well mixed. This implies that the dissolved oxygen should drift up smoothly when the evaporator condensate return pump started, and drift down smoothly when the pump is stopped.
