Power Outage

COVEY CASE STUDY

Procex Pty Ltd (an associate of Covey Consulting) investigated the root causes of a power outage and subsequent damage at a glass manufacturing plant.

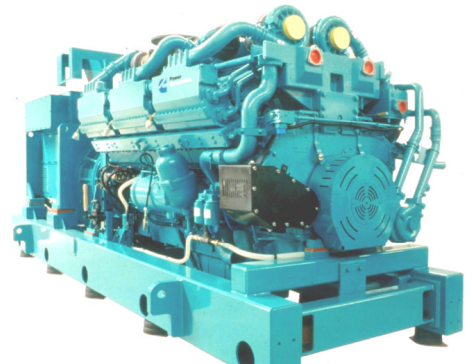
The investigation found that failure of batteries in the backup power supply of the standby diesel generator Control Unit caused the circuit breakers connecting the incoming power and the diesel generator set to trip. Failure of the batteries was most likely precipitated by high temperatures in the switch room.

The failure of the batteries alone should not have caused the trip. However, the parallel connection to the generator set main batteries had not been reconnected following system commissioning and testing several months before. Therefore, the Control Unit had been totally supported by the backup power system since start-up.

Following the power failure, the gas blocking valves for the furnace did not go to their fail-safe positions. This was traced to "sticking" of both the solenoid valves that supply air to the blocking valves. Inspection of the valves showed some material deposited on the solenoid plunger and a matching pattern of similar material inside the barrel of the plunger guide. Analysis of this material by Covey Consulting showed that it was primarily hydrocarbon oil that matched with a sample from the air compressor lubrication oil.

Operating crews had not been aware that the gas continued to burn and this resulted in damage to the furnace heat recovery system.

- Reconnect primary DC power from generator set
- Install air conditioning to control Switch room temperature
- Improve the alarming of faults
- Shield gas train solenoid valves from heat radiated from furnace
- Install more appropriate solenoid valves
- Install filters on the plant air supply
- Add energy usage and heat recovery performance calculations to the SCADA system.
