COVEY CASE STUDY

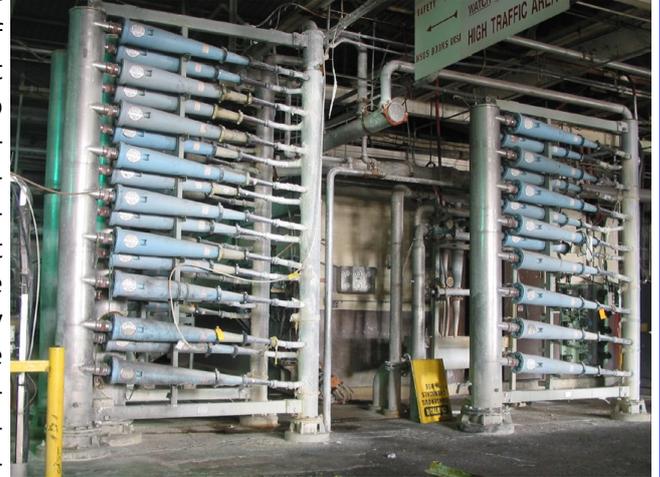
The main problem was that although the cleaners worked quite well when recently cleaned, they soon began to block and then efficiency dropped and wear of elements increased. Because of the canister design, it was not possible to clean elements without completely stopping production. A second problem was that the throughput of the cleaners changed fairly regularly, and hence they were rarely operating at maximum efficiency. When we inspected the units we found a third problem – some of the elements were exhibiting re-verse flow, and actually re-introducing the rejects into the accepts stream.

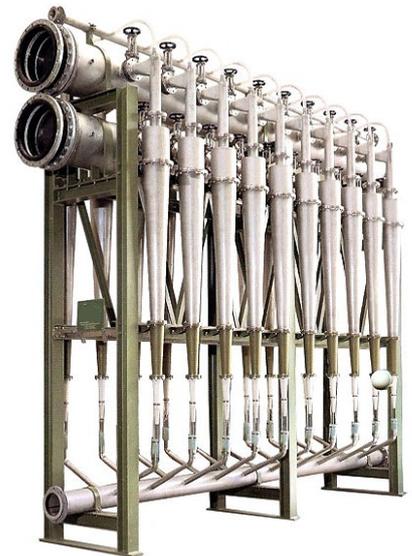
It was apparent that the cleaners would need to be replaced, but money and space were limited. Fortunately, we located some much older, but still fully serviceable, modular cleaners on a disused machine at another of the company's sites. These could be modified (larger frames and improved troughs and instrumentation) but they had far too large a footprint to install in place of the existing units.

We identified an opportunity to relocate a few pipes and create a new platform on a pipe bridge structure close to the existing cleaners. This gave an added advantage that most of the modification work could be done while the plant was still running, with the switch occurring during a short, scheduled shut.
